RE: Bond Release Information, Beaver Creek Coal Company, Huntington #4 Mine, INA/G15/OO4, #5, Emery County, Utah

RE: Approval of Phase I Bond Release, Huntington #4, ACT/015/004 #5, Emery County, Utah

Phase I Bond Release Inspection at Huntington #4,

ACT/015/004, #5, Emery County, Utah

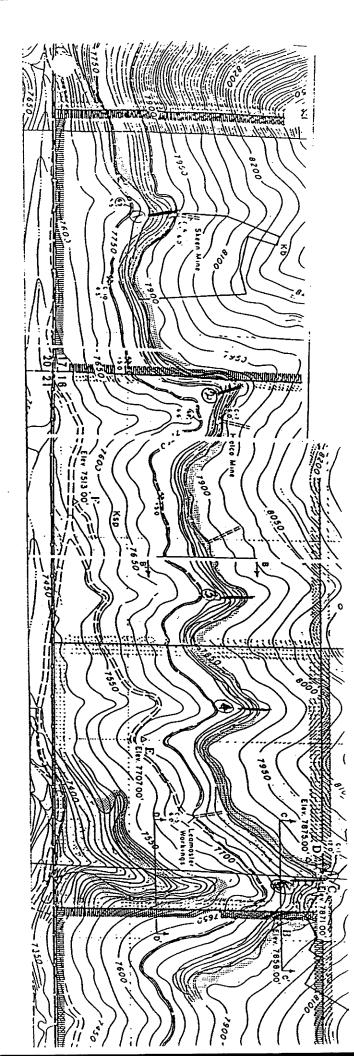
PLATE 3-8
HUNTINGTON #4 RECLAMATION
POST-MINING TOPOGRAPHY
ORIGINAL SCALE 1"=200'

Plate 3-8 in the approved plan indicates the reclaimed (post-mining) topography. A reduced copy of this plate (attached) designates areas in drainages (totalling less than a half acre) that may be potential erosion problems. The steepness of the terrain and intensity associated with thunderstorms may require some earthwork and repair in the future. Some tension or settling cracks were noted that should be observed and monitored in the future.

NOTE: DRAINAGES AND SETTLING OR TENSION CRACKS INDICATED

The Division recommends Phase I bond release (60% of the bond, \$216,062.40). This recommendation is based upon the backfilling and grading and drainage control that has been completed at this site. Although there is the possibility of more work that may be needed for the repair of the rills and gullies, monies have already been included in the annual monitoring costs for this work, \$11,840/year.
